AMERICAN SOCIETY OF CIVIL ENGINEERS

DECEMBER, 1955

KELLY AIR FORCE BASE MAINTENANCE HANGAR: CONSTRUCTION FEATURES

by W. H. Fasshauer, A.M. ASCE,
and C. W. Edwards

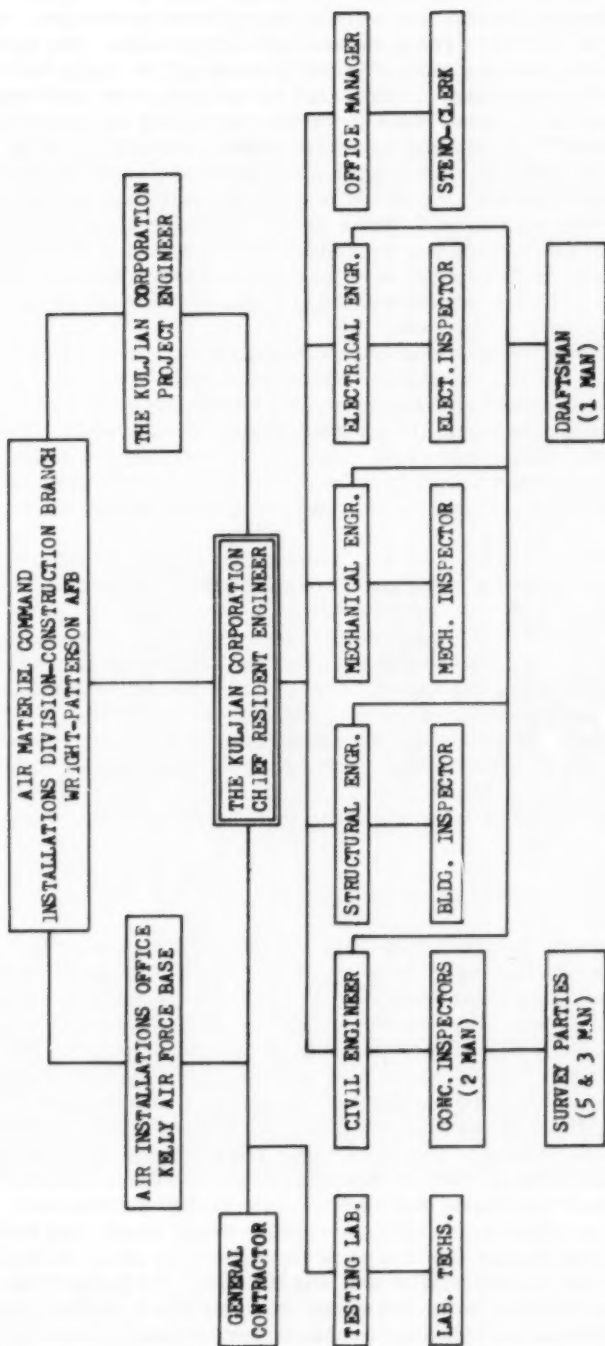
CHART - 1

ORGANIZATION CHART

In general paper work flowed from the contractor to the Chief Resident Engineer who, after furnishing additional data, justification and comment, forwarded the file to the Air Materiel Command, Wright-Patterson AFB, Dayton, Ohio, through the Air Installations Office, Kelly Field, with copies to the general contractor, the contracting officer, the Kuljian Home Office and other agencies, if particularly involved. Instructions and decisions from Air Materiel Command were passed down through the same channels in reverse order (Chart 1).

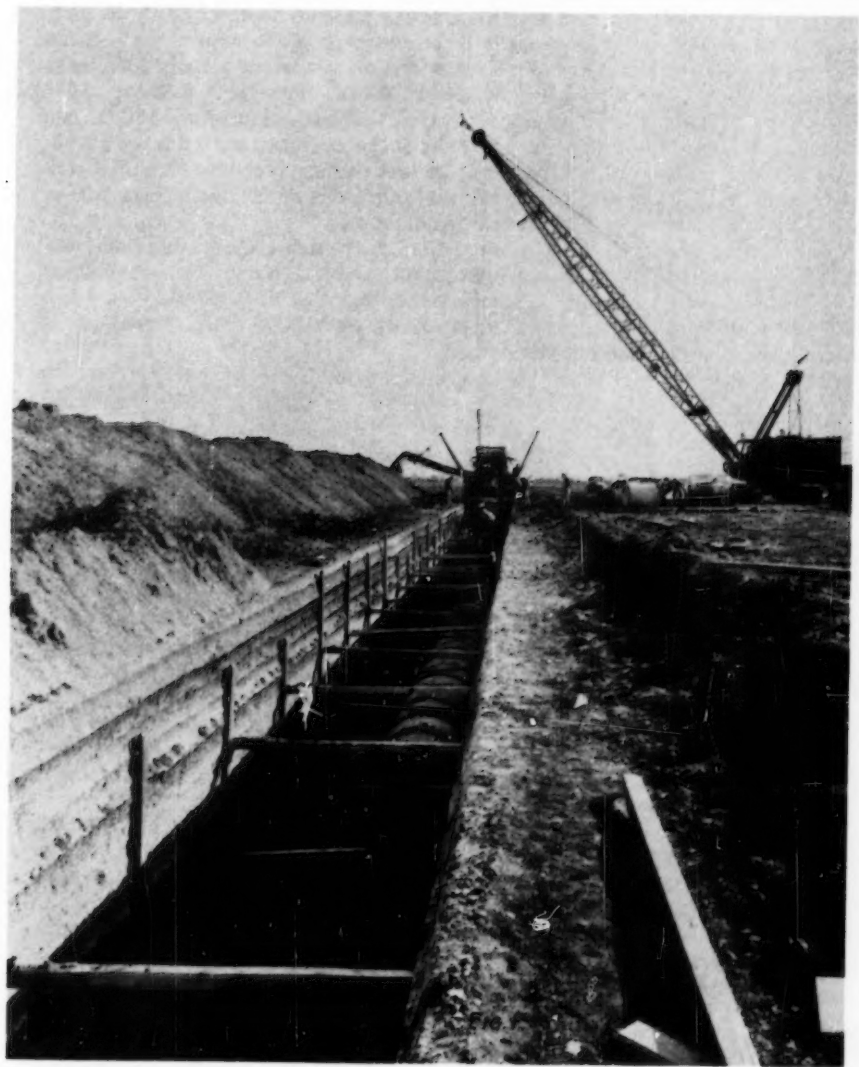
To accommodate the facility a new sixty-six (66) in. diameter, T & G concrete storm water drainage line was installed, running a distance of nearly one mile from the hangar site to Leon Creek. It was deemed advisable to have this drainage system in operation promptly so as to keep the site as dry as possible. The contractor started this main drainage line at Leon Creek terminus, with direction of placement toward the hangar. Depth of excavation ran from twenty (20) ft. below grade at the hangar to nearly thirty (30) ft. below grade going under the military highway. Rigid field inspection was necessary to maintain the specified slopes, backfill and the precise joining of the sections of this sixty-six (66) in. line (Fig. 1).

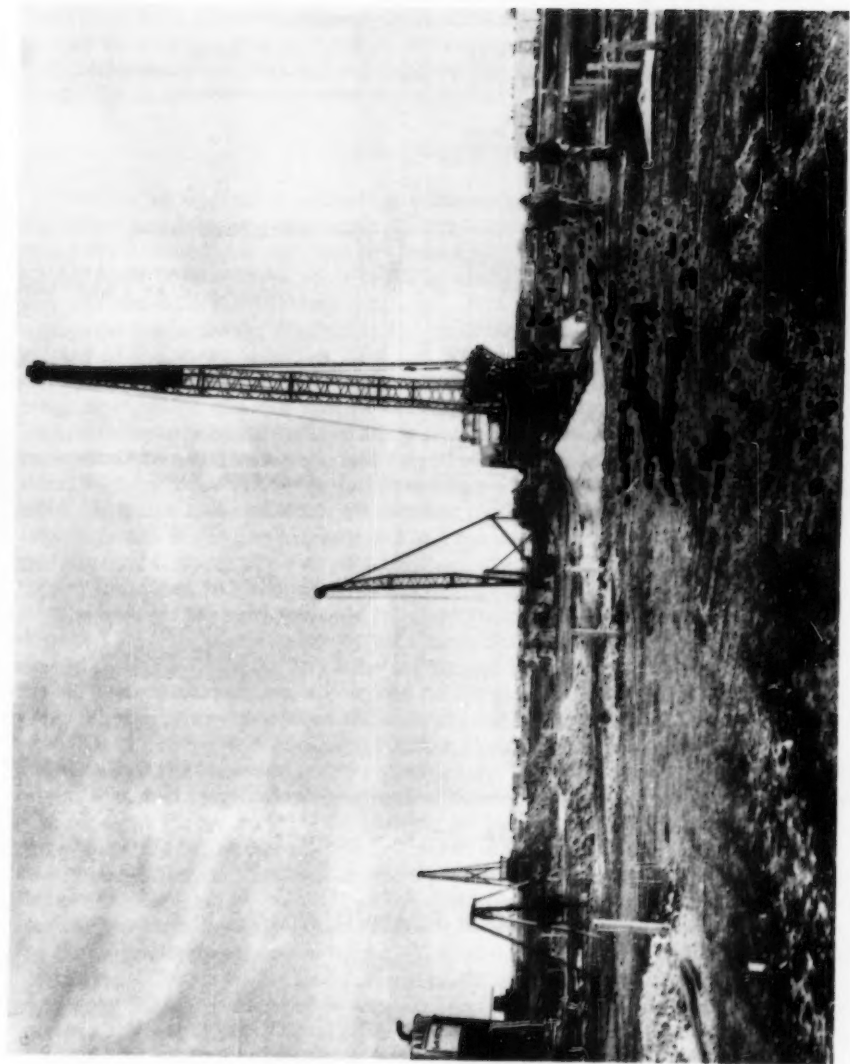
1. Oversized shaft was drilled in the ground after the completion of surface compaction (Fig. 2).
2. A one-piece metal caisson tube was set plumb, and driven into the impervious material (Fig. 3).
3. Pea gravel was placed around the side of the caisson tube.
4. Excavation was continued below the caisson tube to a suitable foundation.
5. An under-cutting bit or reamer was then used to undercut the bell bottom to required dimensions.
6. After inspection of the foundation material and cleaning out of the loose dirt, reinforcing steel cage was lowered into the shaft.
7. Concrete was then poured into the shaft in one continuous pour, from the bottom of the piling to the top of the caissons.
8. The caisson metal tube was immediately withdrawn after the concrete operation was completed.
9. The top of the caisson pilings was brought to a proper grade thus completing the caisson operation.

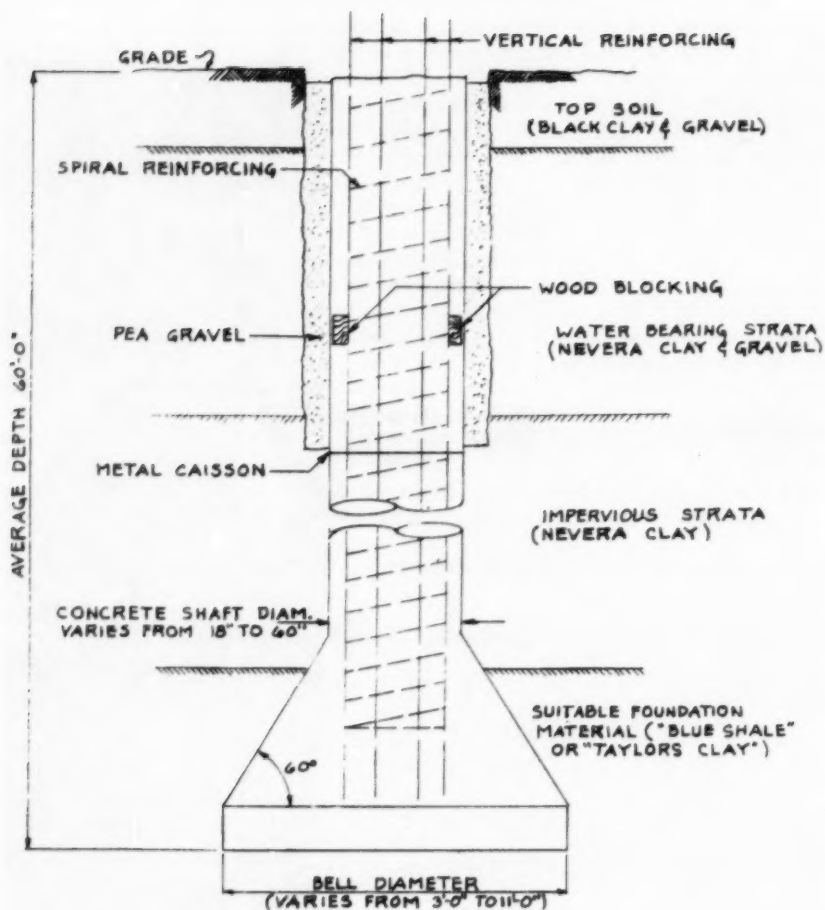
FIG. 3

TYPICAL UNDER-REAMED PILING

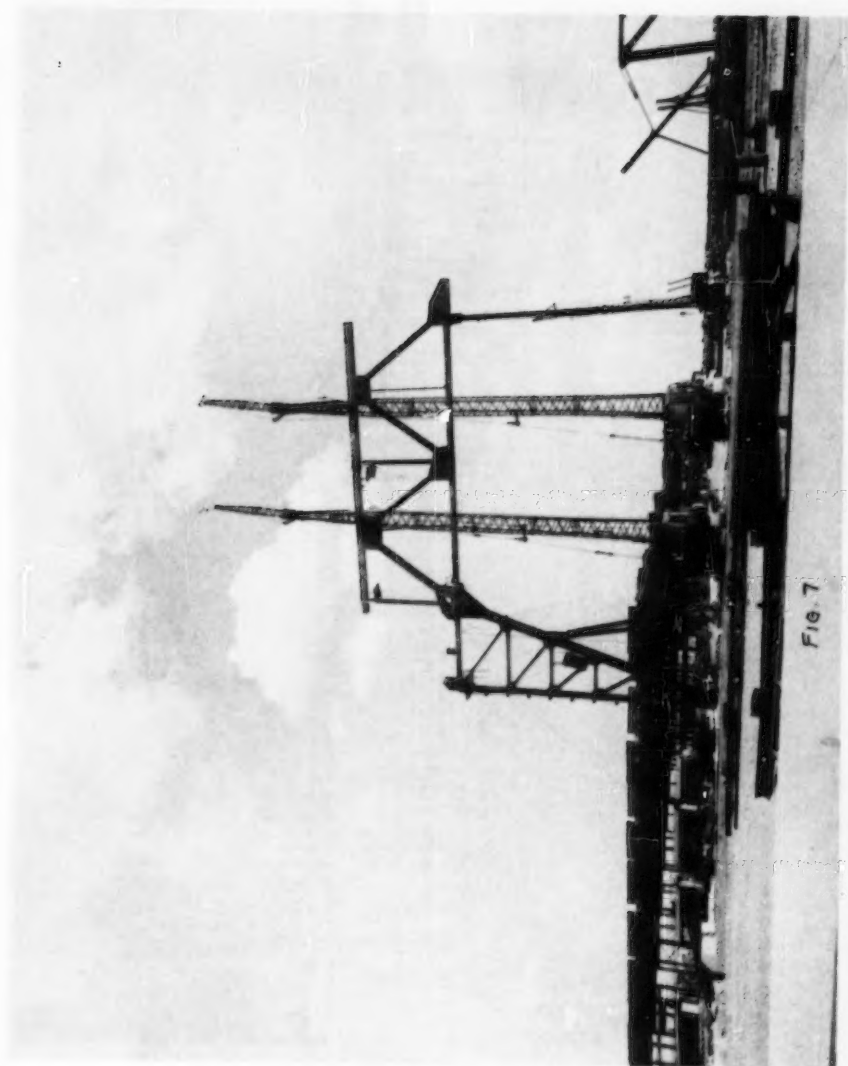
FIG. 7

5. Falsework bent "B", equipped with a pair of heavy 300-ton hydraulic jacks, was erected and guided in position to receive assembled unit #2. The assembly of the rigid truss frame unit #2 having been completed on the ground and weighing 56 tons, was lifted with the same pair of derricks and was bolted in position (Fig. 7).

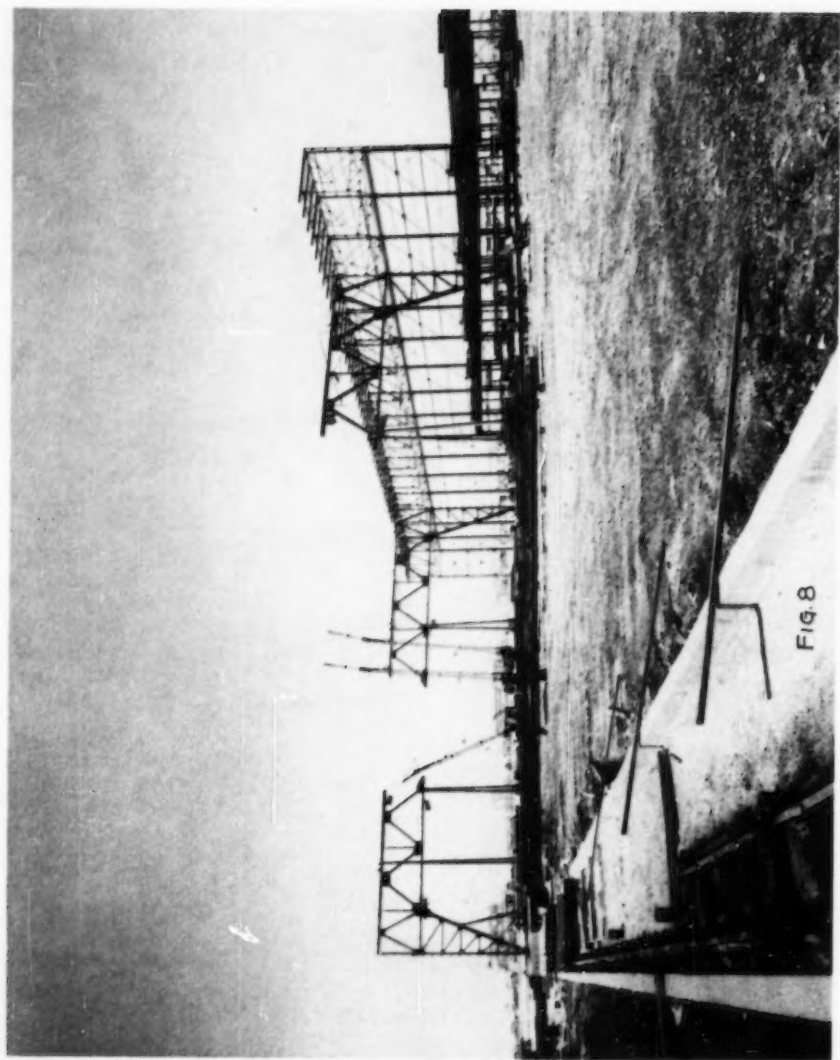
6. The foregoing operation was repeated in similar sequence for the next rigid truss frame 250 ft. away.
7. The two double cantilever trusses immediately over the stiff legs were assembled on the ground. Weighing 23 and 32 tons, respectively, they were then raised to fill in between the already erected partial rigid truss frames. To provide lateral stability for the 250-foot longitudinal truss during erection, temporary horizontal stiffening trusses, each 130-feet long and 4 feet deep, were employed and bolted to the top chord of the 250 ft. long and 24-ft.-9-in. deep trusses to provide horizontal stiffness. The temporary bracings were removed after filling in top and bottom chords, struts and sway bracings required for permanent stability (Fig. 8).

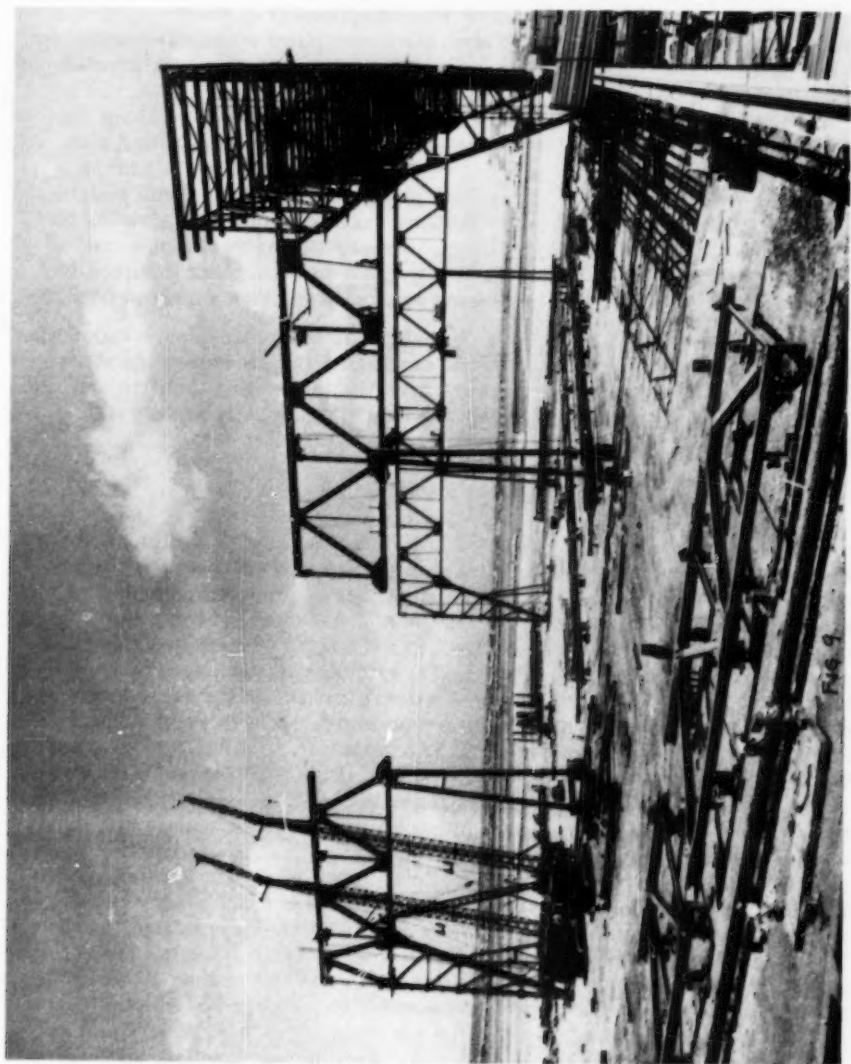
11. The center portion of the two rigid truss frames (unit #3), assembled on the ground, was then raised into position, and with the necessary fill-ins, was firmly connected. False-work bents were jacked up to the amount necessary to make the connections (Fig. 9).

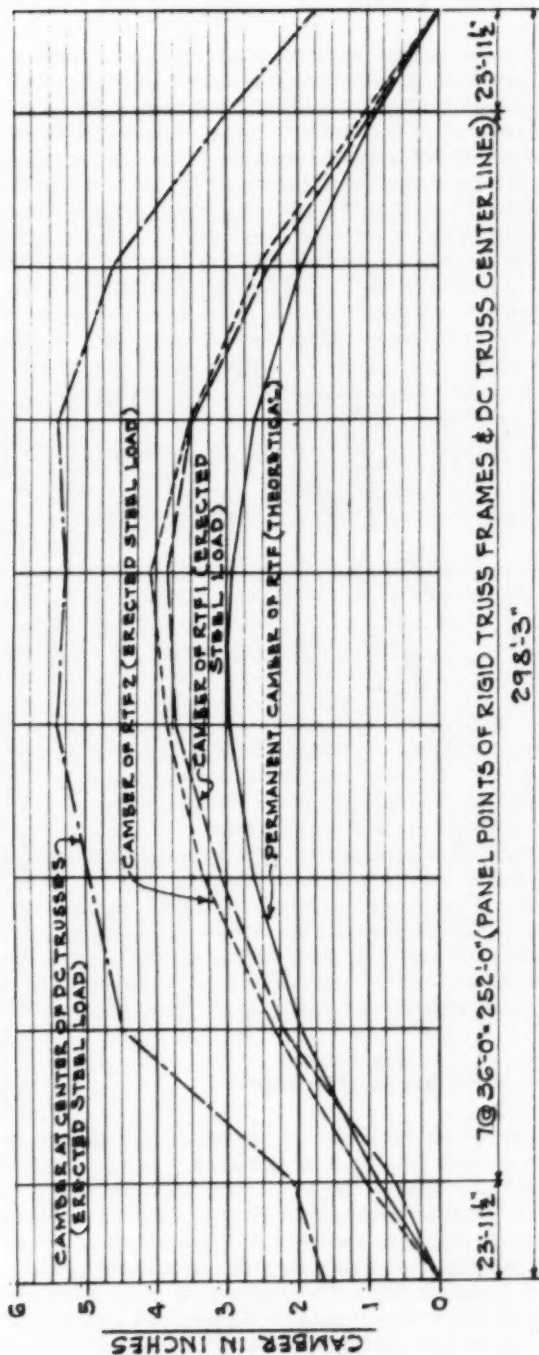
FIG.12

To be able to obtain the proper camber after the dead load deflections of the large-span trusses have been taken out, provision was made in design and fabrication for all the cantilever ends of the double cantilever trusses to be erected with necessary shims, half-inch in thickness, at the bottom chord connections to the rigid truss frames. In the course of steel erection and after completion of the hangar structure, camber readings were taken of both rigid truss frames and double cantilever trusses in the early morning, noon, and in the evening. Reference temperature readings were also taken at the same time. Attempts were made to adjust the camber to a satisfactory elevation under corresponding dead load (Fig. 12). The unlocked hinges of the rigid truss frames also have been observed to determine the effect of temperature changes. The center line of the steel masonry plate was clearly established when the center line of the rigid truss frame was marked on the sole plate. These demarcations indicate relative sole plate movement with respect to the stationary base plate. Their values are plotted on the submitted graph with temperature readings as ordinates, and position of rigid truss frame sole plate as abscissae to indicate the relative movement. Steel was fabricated at the 68° F. shop temperature, and at this temperature (theoretical), the center line of the sole plate had to coincide with the center line of the steel masonry plate. From the attached curves, however, it is seen that the ratio of the translation and change in temperature, although constant, do not coincide with the theoretical curve. This discrepancy is attributed to the friction at the base and the resistance offered by tie beam supports (Fig. 13).

RELATIVE CAMBER OF RIGID TRUSS FRAMES

All in all, it could be said that the actual deflections coincided very closely with the predicted deflections.

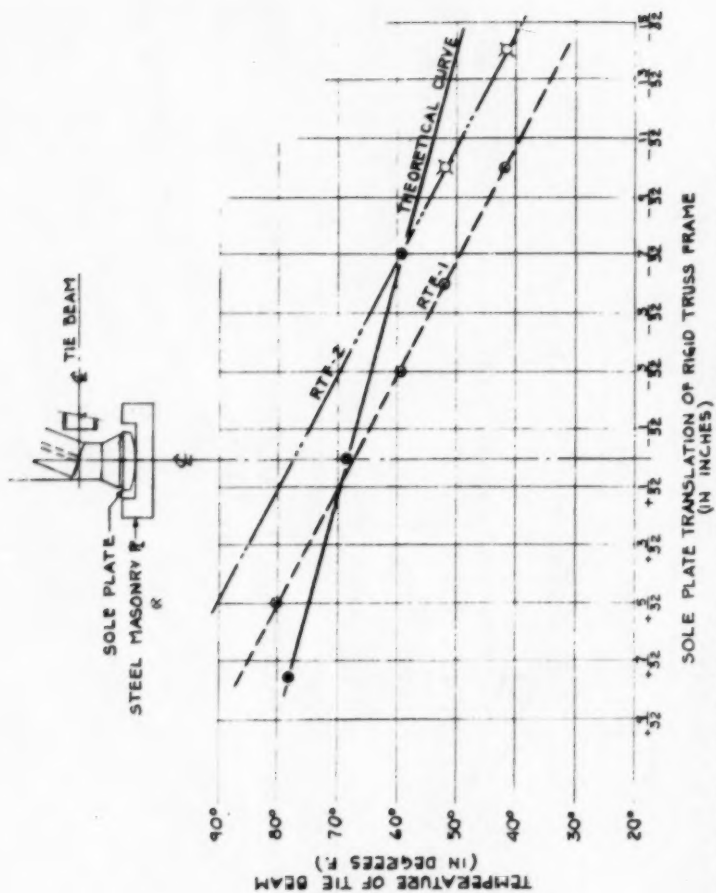
FIG. 13

CURVES INDICATING RELATIVE SOLE PLATE MOVEMENTS OF RIGID TRUSS
FRAMES WITH REGARD TO TEMPERATURE VARIATIONS IN TIE BEAMS

*, DENOTES EXPANSION (INCREASE IN TIE BEAM)
(-), DENOTES CONTRACTION (DECREASE IN TIE BEAM)

During the erection period of principal hangar steel in the summer of 1954, it was noted that considerable movement occurred in the exposed 14" WF tie beam at the end connected to the unlocked heel of the rigid truss frame. An accurate calibration of maximum movement was recorded and found to total about 1-1/2" in approximately 300-ft. tie beam length. With the advent of the winter season the beam contracted and remained in that position until March, when with the coming of warm weather, elongation occurred once again. In the interim an order from the Chief Resident Engineer prohibiting the placing of concrete floor slab unless protected by a water-tight roof had stopped the placing of the hangar floor. However, by early February sufficient area of the hangar roof had been placed to warrant the starting of the hangar floor slab (Fig. 15). At that time the weather was cool and the tie beam was still in a contracted position. To allow the contractor to proceed with the paving it was necessary to secure and permanently lock the sliding base plate connection in its calculated and centered position. This was based on the assumption that a temperature of approximately 70° F. would prevail within the enclosed trench under normal service conditions. It was, therefore, required to elongate the tie beam to an amount necessary to facilitate connection of the sole plate under this normal trench temperature.
